# Technical Bulletin

## TB 0350 - Categorisation of Substation Polymeric-type Bushing Defects for Substation Inspection Programs

**Date:** 12/06/24

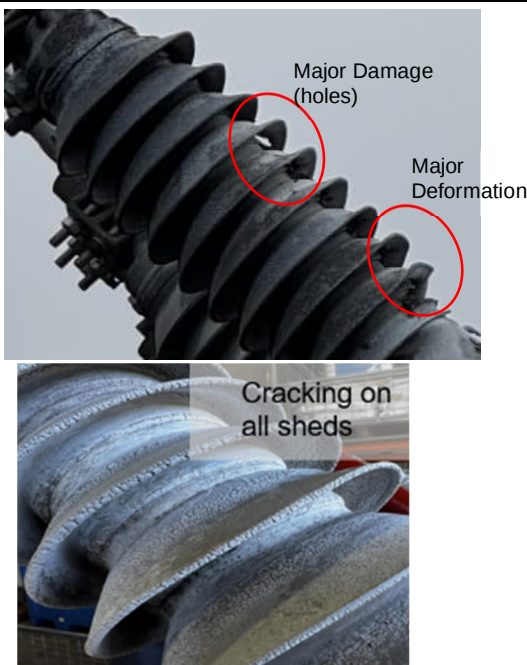
| Defect Description | Photos | Actions |
|---|---|---|
| <p>Polymeric Insulator – Major Damage/Deformation</p> <ul style="list-style-type: none"> <li>- All sheds display cracks or holes.</li> <li>- More than half of the sheds display major deformation or warping</li> </ul> | | <p>Inspector to Raise SAP Notification:</p> <ul style="list-style-type: none"> <li>- SAP Priority 6 (1 month)</li> <li>- Attach Photos</li> <li>- STD JOB 1TRBSH</li> </ul> <p>Issue Notification through SAP to the Work Center.</p> <p>Work Centre will review and create WOs as required.</p> |

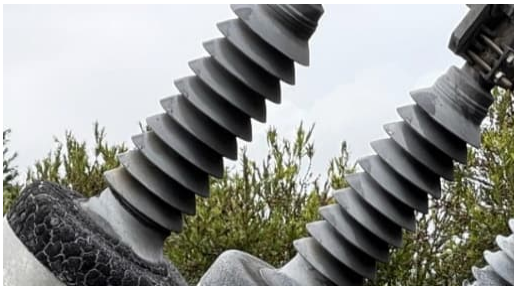
| Defect Description | Photos | Actions |
|---|---|---|
| <p>Polymeric Insulator – Minor Damage</p> <ul style="list-style-type: none"><li>- Damage to 3 or more sheds.</li><li>- Cracking on 3 or more sheds</li><li>- Insulators have lost their hydrophobic properties</li></ul> | | <p>Inspector to Raise SAP Notification:</p> <ul style="list-style-type: none"><li>- SAP Priority 9</li><li>- Attach Photos</li><li>- STD JOB 1TRBSH</li></ul> |

- Replacement of all six (6) bushing on the CB
- Replacement of the CT cover

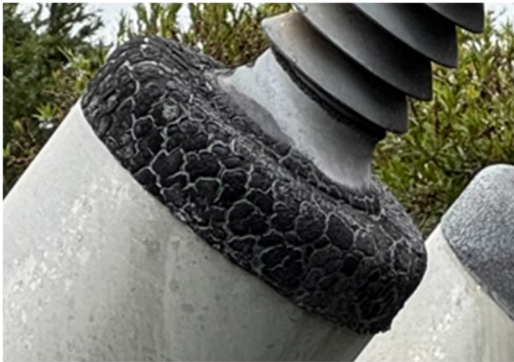
| Defect Description | Photos | Actions |
|---|---|---|
| <p>Polymeric CT Cover/Boot – Damage</p> <ul style="list-style-type: none"><li>- CT cover boot had lost its hydrophobic properties.</li><li>- Significant cracking/damage on CT cover</li></ul> | | <p>Inspector to Raise SAP Notification:</p> <ul style="list-style-type: none"><li>- SAP Priority 9</li><li>- Attach Photos</li><li>- STD JOB 1TRBSH</li></ul> |
