## TB 0371 – Failed NOJA Recloser Rectification

Date: 15/07/2025

This technical bulletin has been issued to communicate the scope of rectification works associated with termination failures of NOJA reclosers models OSM 200 & OSM 300.

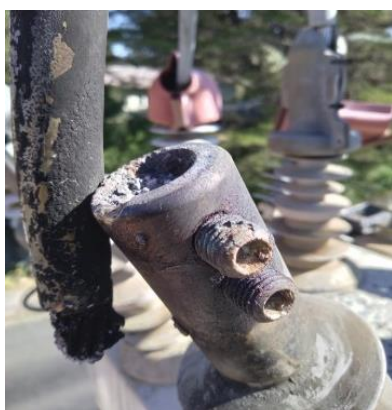
Recent inspections of failed NOJA reclosers have identified a significant number of termination failures attributed to burnt bonds, where the conductor is secured within the tunnel connectors.

- Connections are becoming loose in the tunnel, leading to hotspots on the terminals and potential subsequent bond failure.
- Accelerated corrosion and oxidisation due to dissimilar metal connection.

Figure 1 - Katoomba Rec 81048  
(14yrs service) – 200 series

1. Remove the tunnel connector to expose the bare terminals.
2. Test the unit with bare terminals as follows:
  - a. Contact resistance test results be less than  $120\mu\Omega$ .
  - b. IR test results shall be greater than  $1G\Omega$ .

If the unit fails either of these tests the entire unit will need to be replaced.

3. Where the unit passes the respective tests: Palm connectors shall be fitted (using the respective palm kit – refer to Table 1 below) and the tests shall be repeated:
  - a. Contact resistance test results shall less than  $120\mu\Omega$ .
  - b. IR test results shall be greater than  $1G\Omega$ .
4. Incoming conductor shall be fitted with  $180\text{mm}^2$  bi-metallic cable lugs and bolted to the palm connectors.
5. Bird guards (refer to Table 1 below) shall be installed over the bare termination where CCT or HV ABC is used.

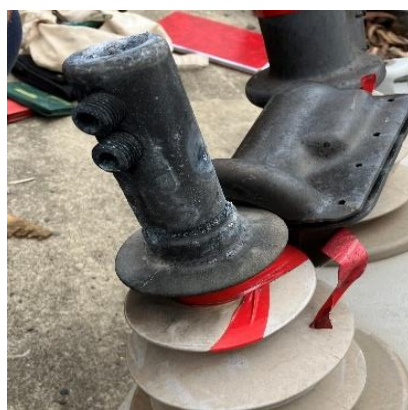
Figure 2 – Helensburgh Rec G0015  
(7yrs service) – 300 series
