Menangle Park Zone Substation | Review of Environmental Factors

Endeavour Energy

Report

5 May 2025

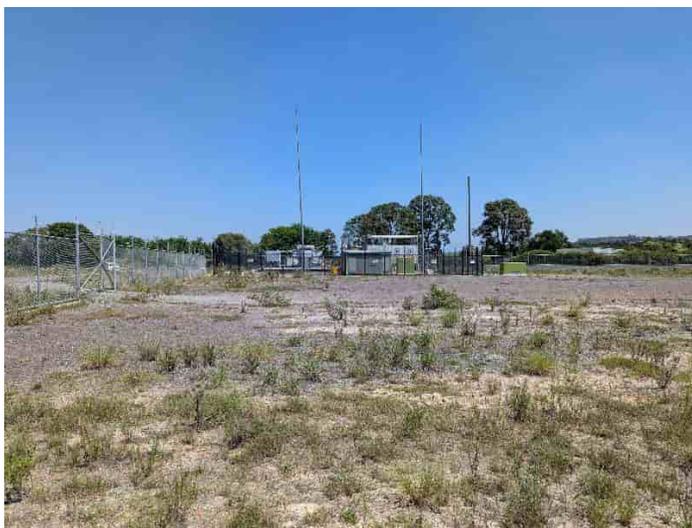
Figure 2-3: Cleared and levelled proposal site facing west.

The proposal site is partially occupied by an existing mobile substation and is already cleared and levelled. The ground surface is unsealed comprising a mix of gravel and natural sediment. Scarce ground cover was observed including grass and weeds emerging through the gravels. A security fence surrounds the perimeter of the site, and a local road connects the proposal site to Fitzpatrick Street, providing traffic access to the ZS.

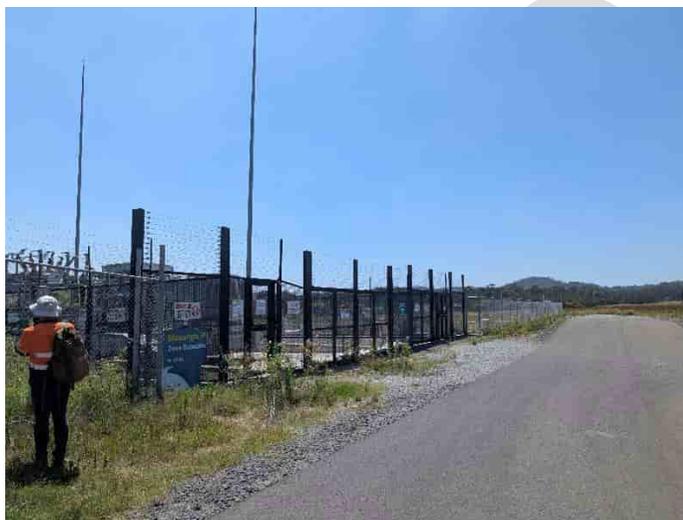
Figure 2-5: Gate around existing mobile substation and access road.

Construction will include occupation of the access road directly south of the substation site for construction parking. The access road is sealed with asphalt with restricted access from Fitzpatrick Street via a lockable gate.

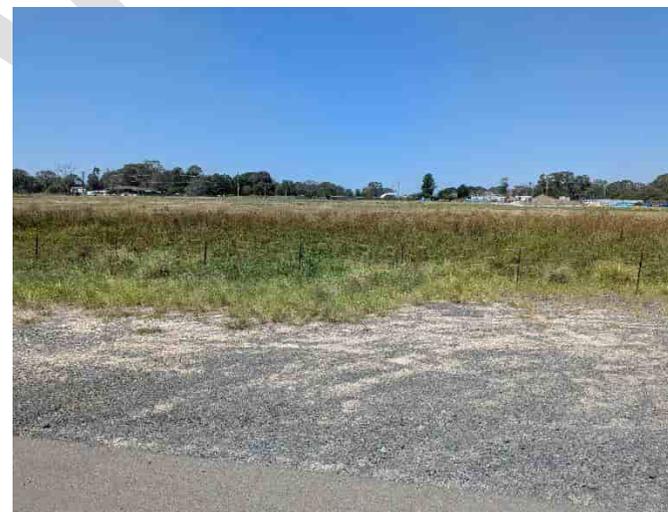
Figure 2-6: South view from proposal

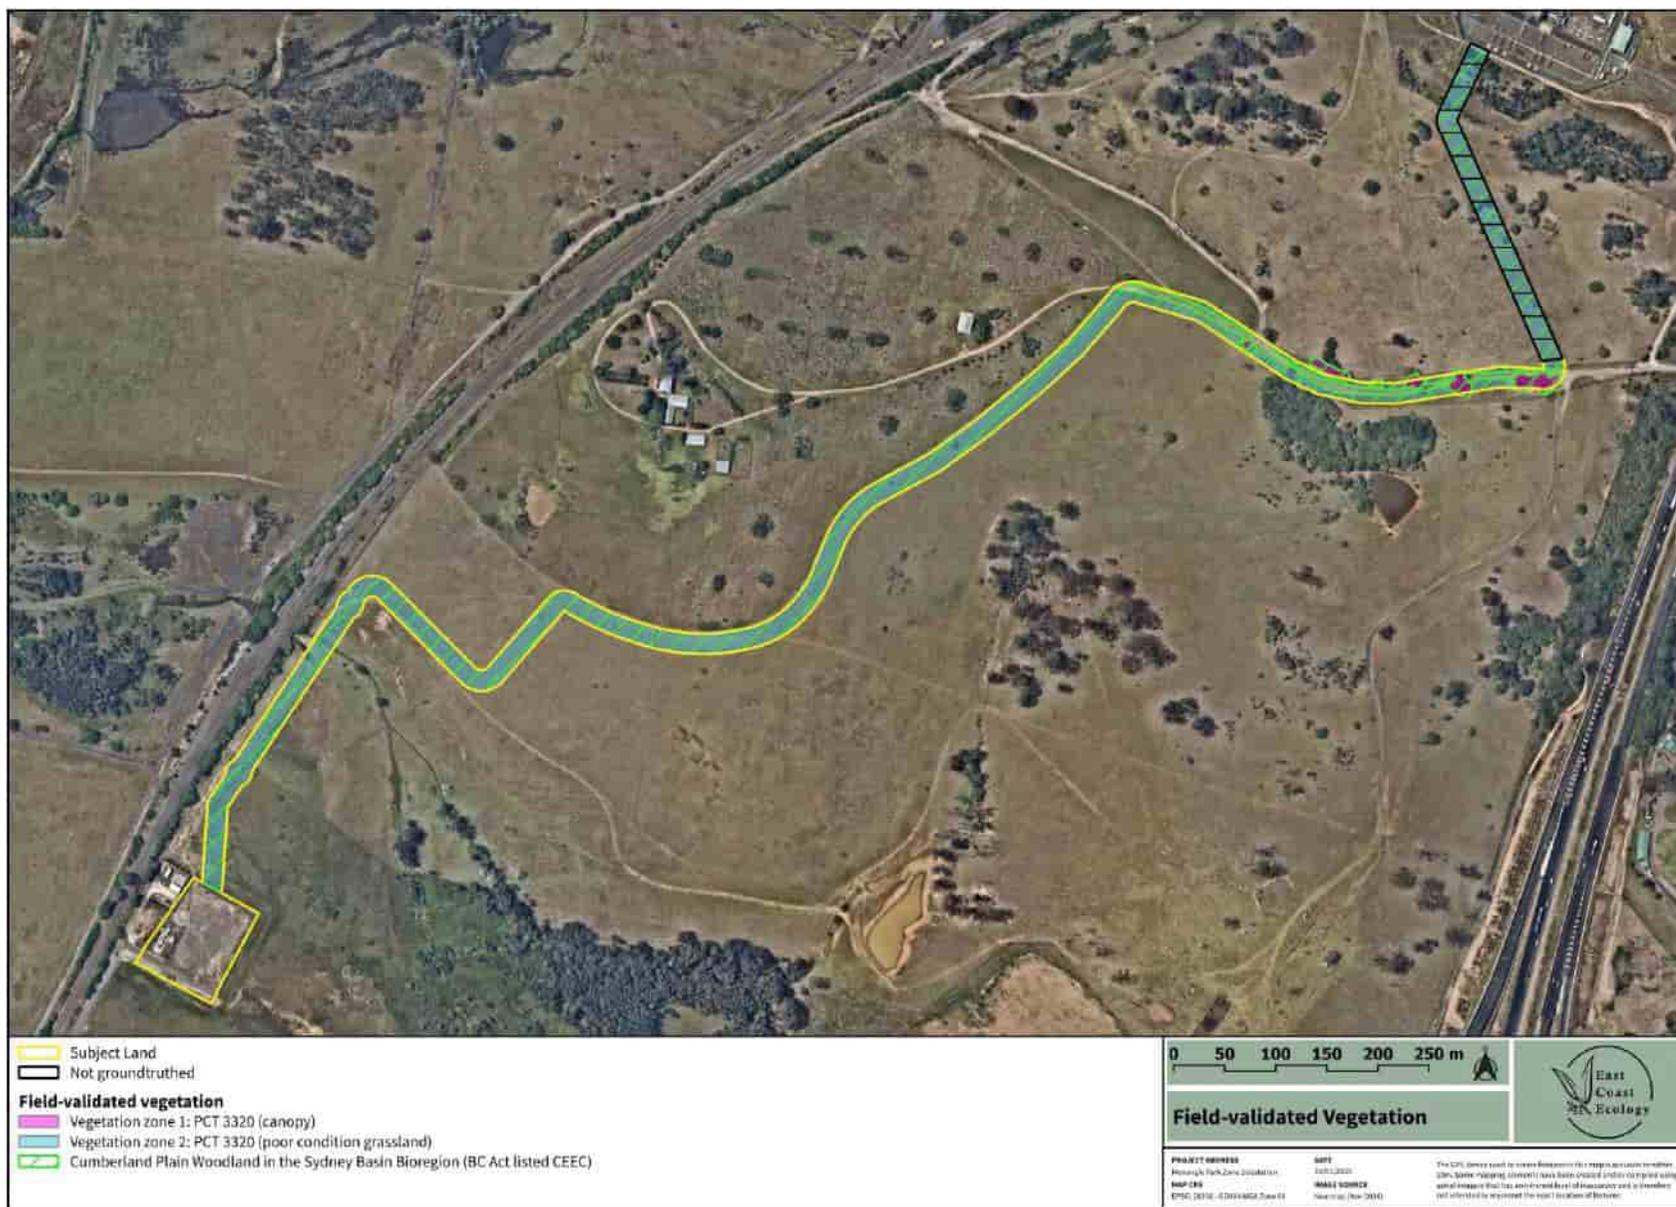
Figure 5-2: Field-validation vegetation communities (Source: BAR (ECE 2025) Appendix D)

The proposal site occurs within a rural landscape which provides minimal wildlife connectivity. Vegetation within and surrounding the proposal site exists primarily as exotic species and is highly degraded and fragmented.

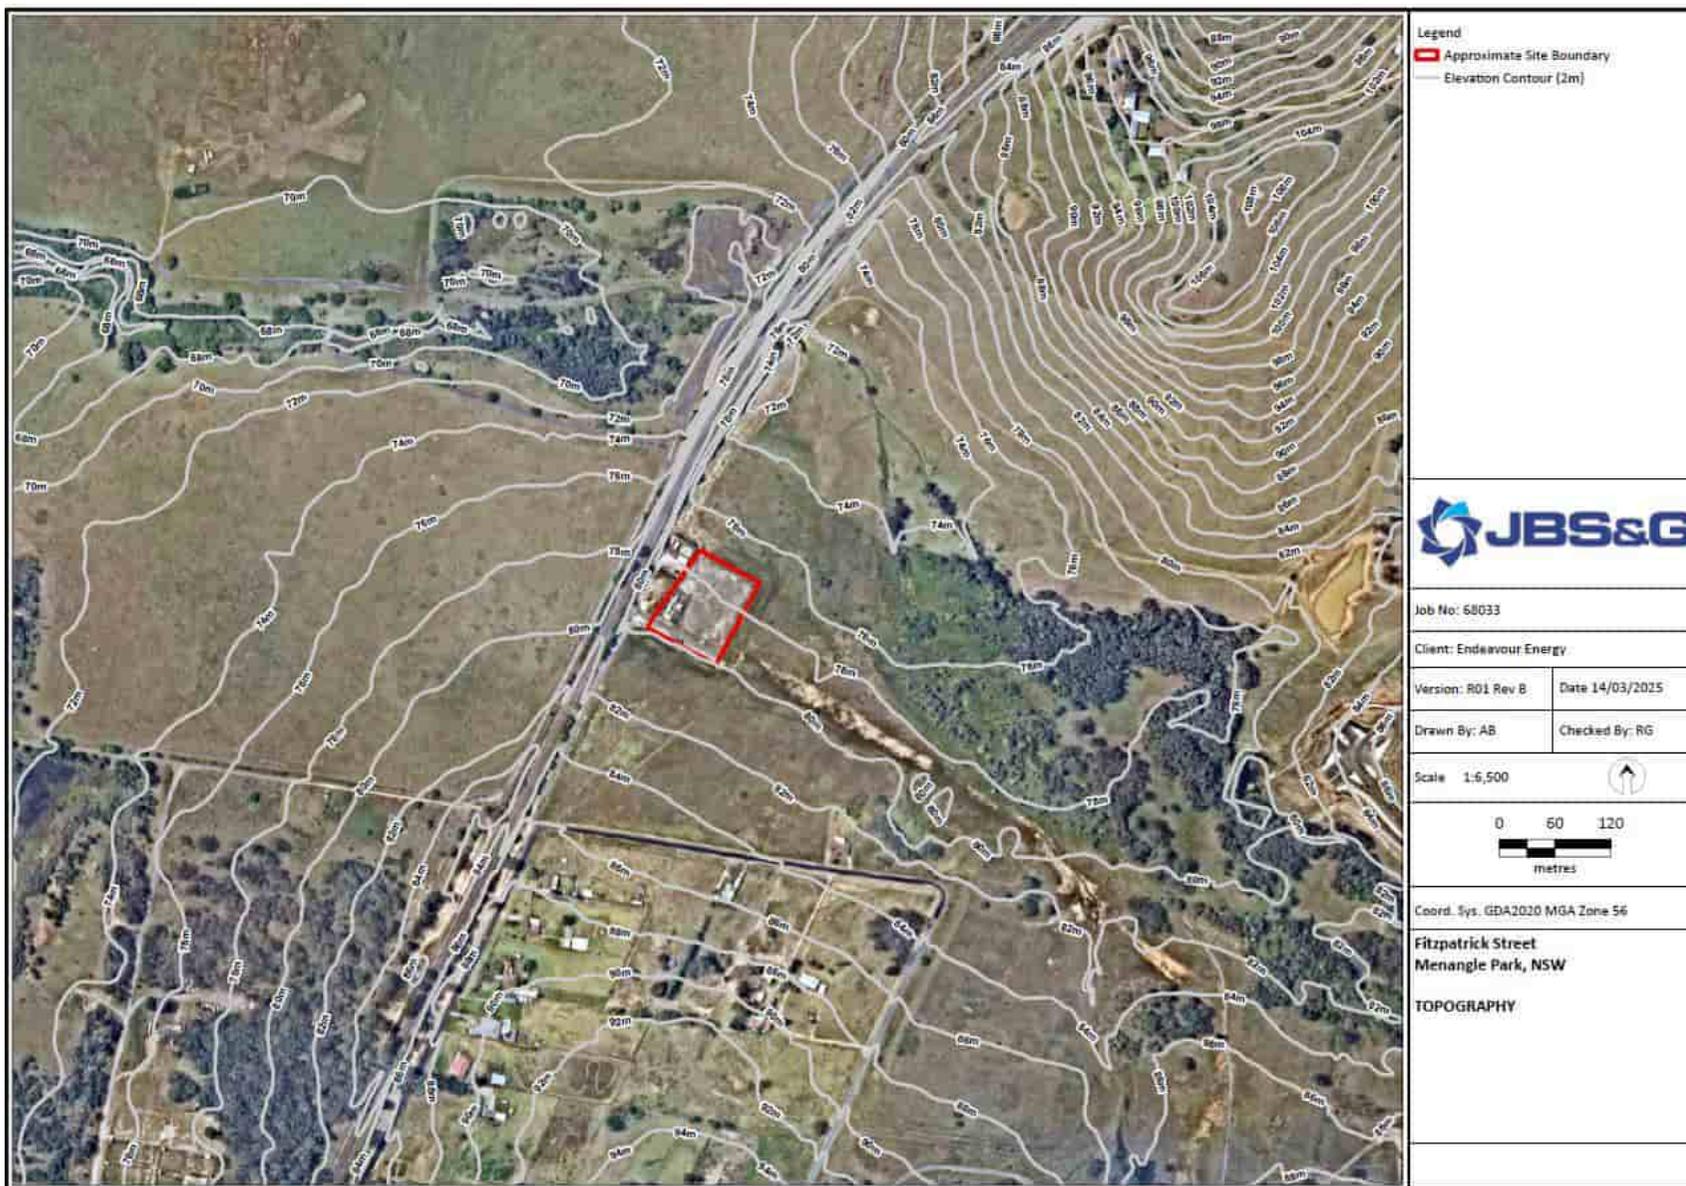
Figure 5-3: Topography at the proposal site

During the site inspection undertaken by JBS&G on 16 December 2024, an area of exposed soils was observed around 312m north from the ZS site, however this was attributed to livestock observed dust bathing in the affected area. No other potential signs of salt scalding, vegetation distress or exposed surface soils associated with a saline prone environment were observed.

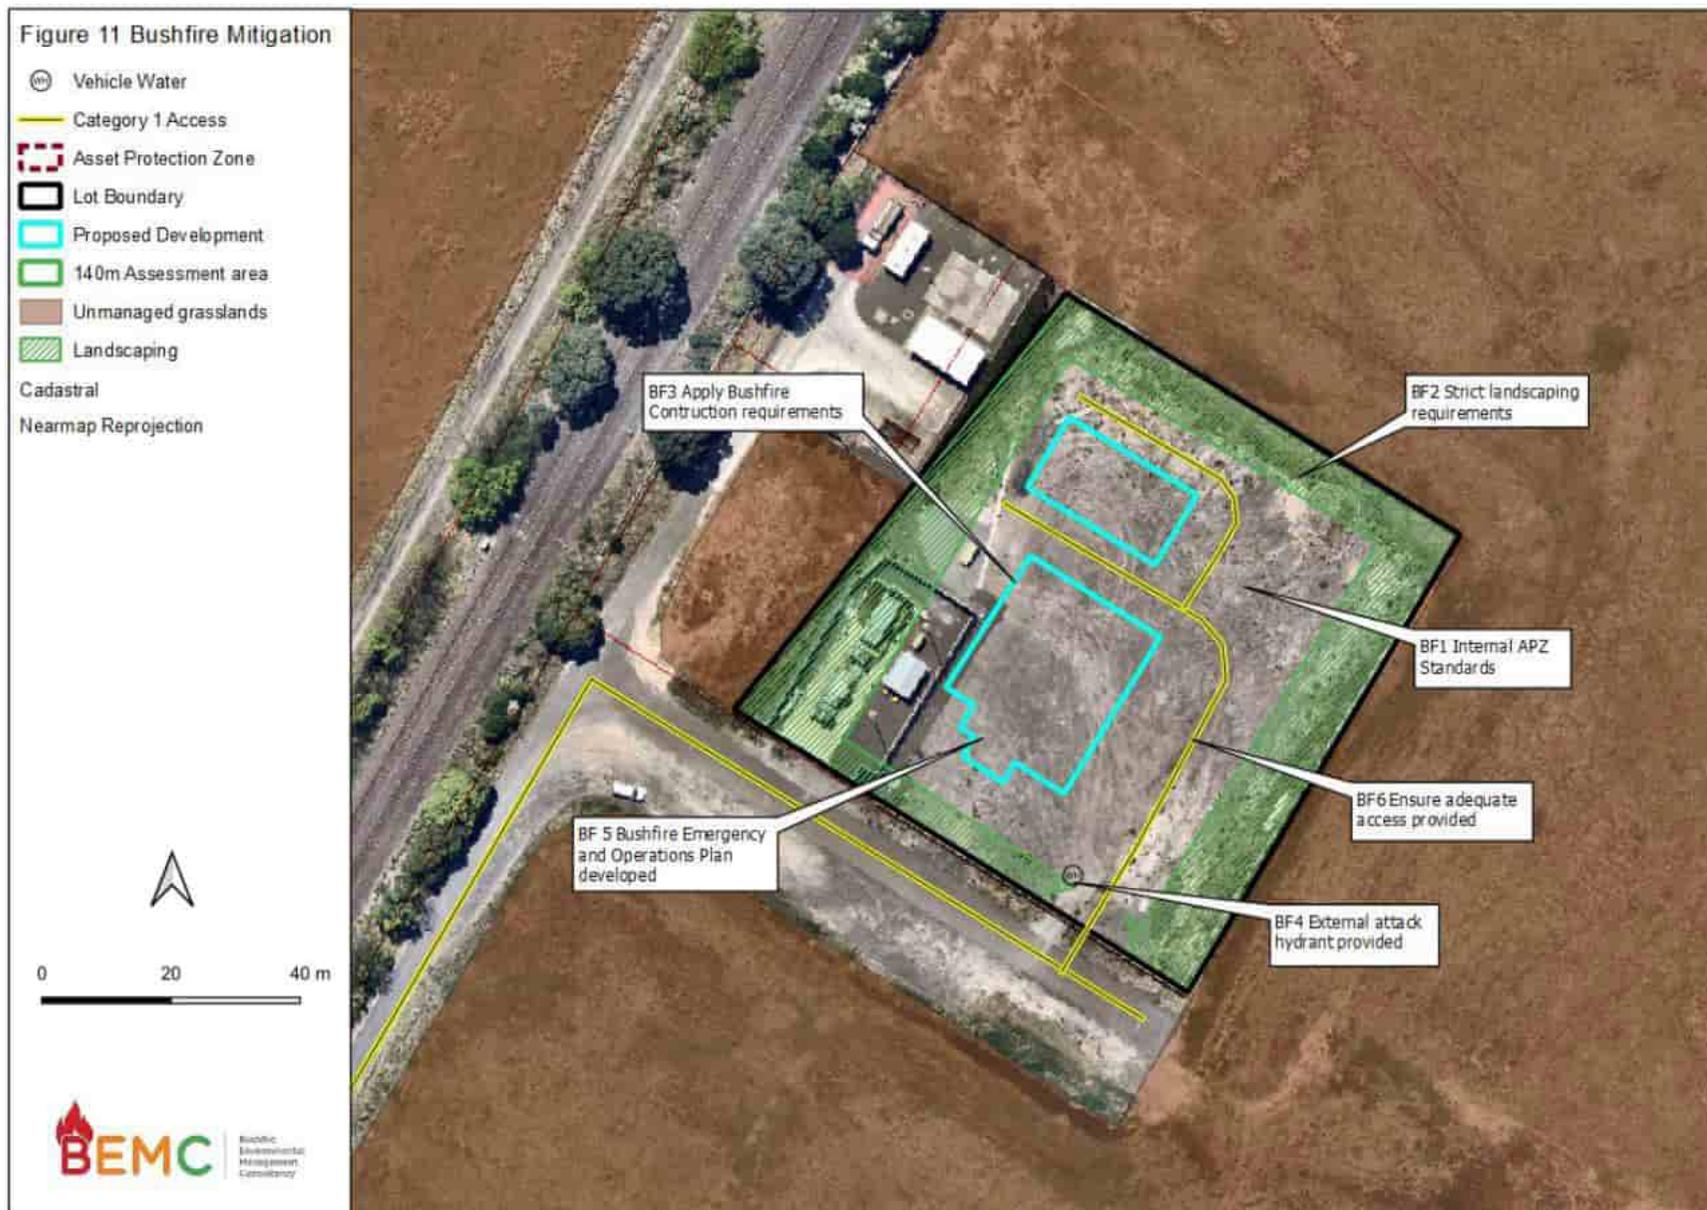
Figure 5-9: Bushfire mitigation for proposal site (Source: BEMC 2025 (Appendix L))

Proposed mitigations to be implemented at the site are presented in **Figure 5-8** below, and would reduce potential bushfire impacts caused by the proposal.

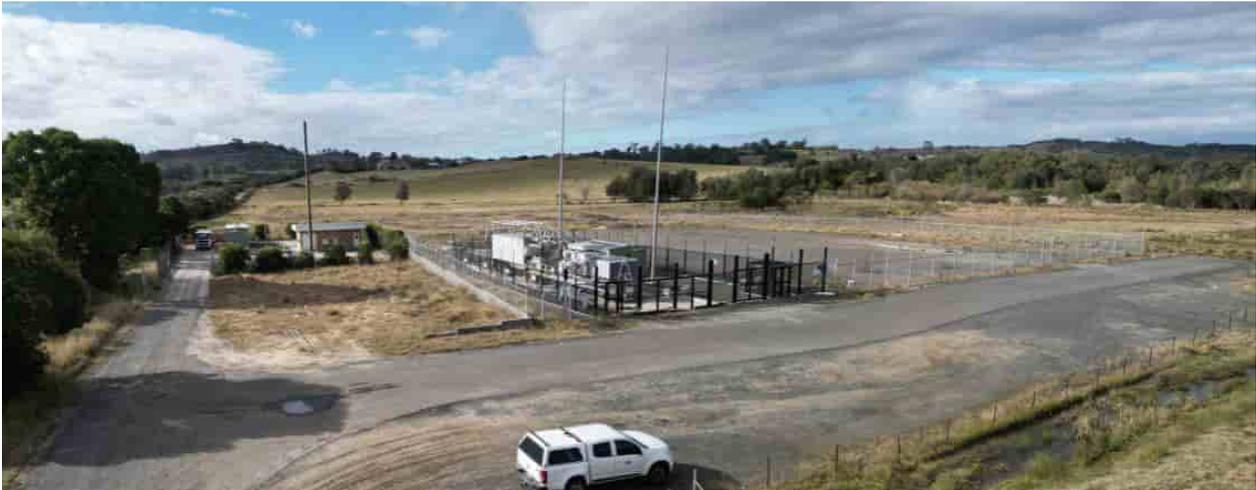
Existing view: Menangle Substation on Fitzpatrick Street:

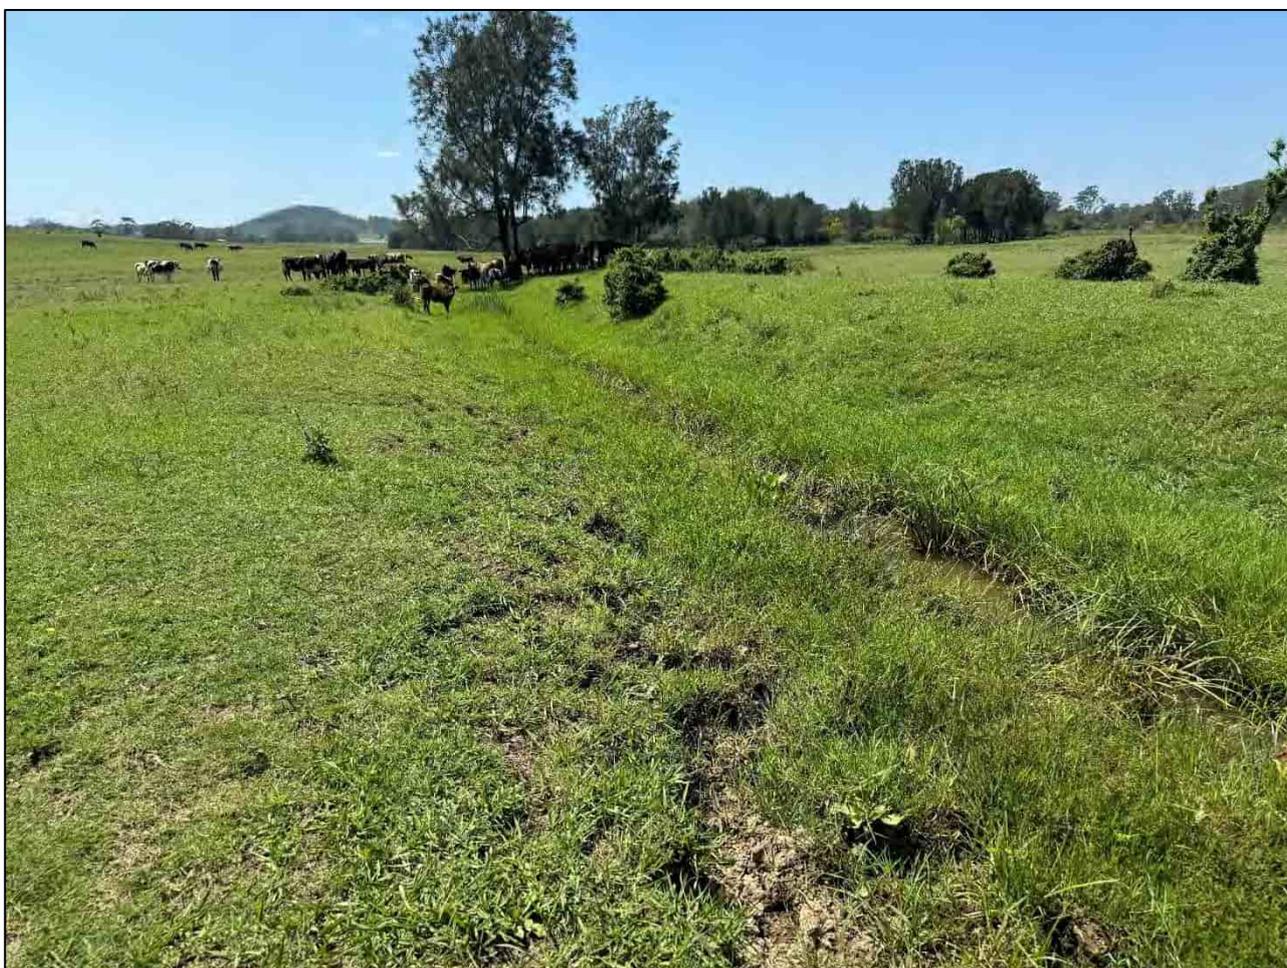
One unnamed mapped watercourse (4th order stream), and its riparian buffer, bifurcates the southern extent of the Subject Land (**Figure 2**). The watercourse, which runs under the train line through a box culvert, was degraded as a result of livestock activity and contained only a small amount of water at the time of the assessment (**Photo 1**). In addition, one unnamed mapped watercourse (1st order stream), and its riparian buffer, bifurcates the northern extent of the Subject Land. The northern extent of the Subject Land was not accessible on the day of the field survey and the presence of this watercourse could not be confirmed.

Photo 1. Unnamed watercourse that bifurcates the Subject Land.

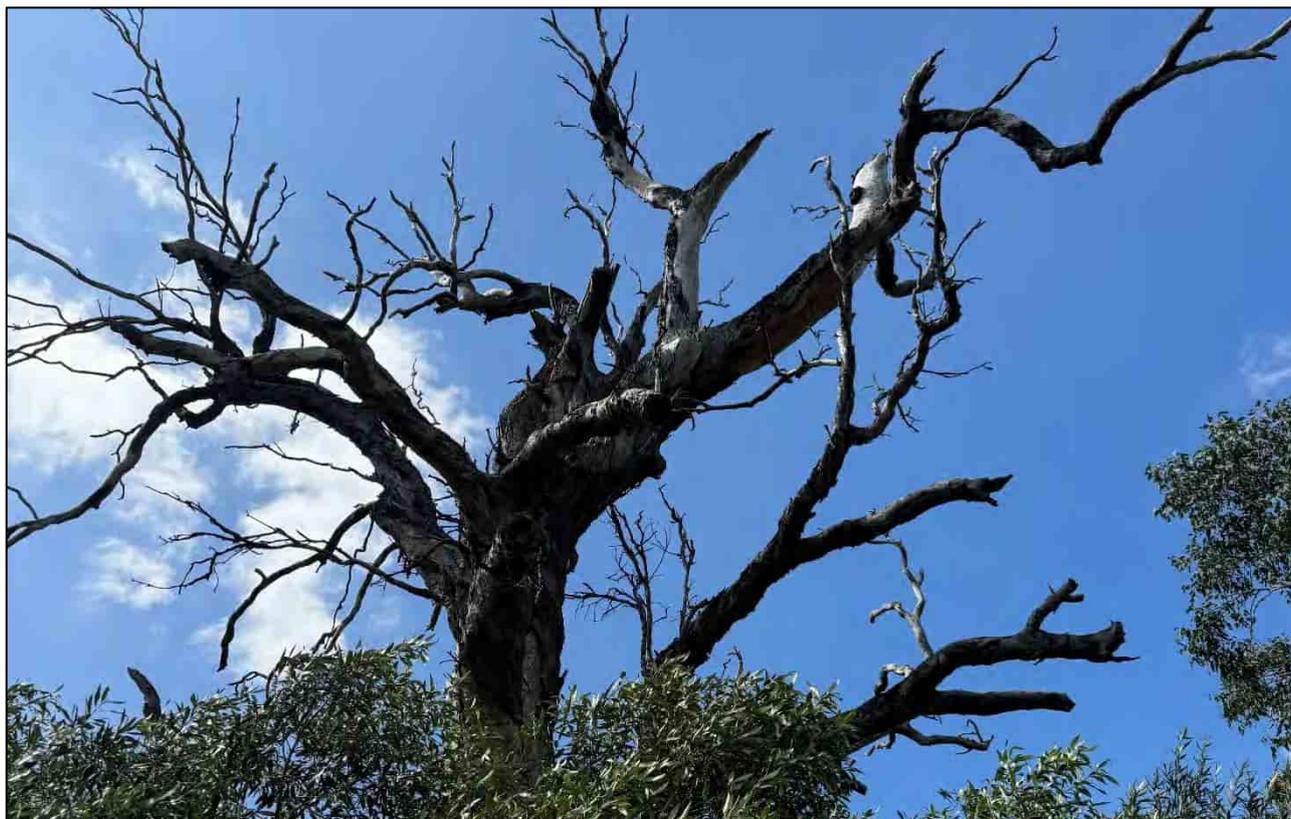
Photo 2. Example of a hollow-bearing stag within the Subject Land.

Two hollow-bearing stags were identified within the Subject Land (**Photo 2**). These hollow-bearing stags contained a range of hollows including 1 x small, 3 x medium, 1 x large and 1 x extra large hollows. It is possible that some of these hollows could provide potential breeding habitat for threatened birds and

mammals, although no signs of breeding were detected during the field survey. The small and medium hollows may be occasionally used for roosting by threatened microbats (e.g. Southern Myotis).

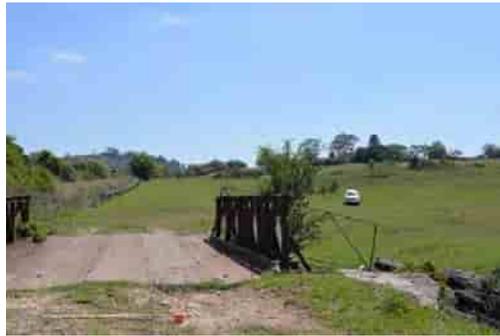
Figure 15: View northeast from northside of bridge crossing over Howes Creek. Large pieces of broken basalt bedrock in foreground

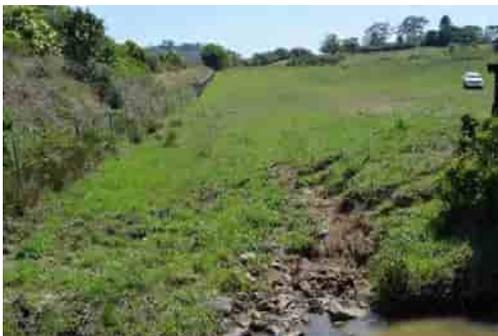
Figure 16: View west of drainage area within channelised portion of Howes Creek that extends through a concrete tunnel under railway line

The southern portion of the study area corridor outside the Glenlee Estate curtilage curls towards the west and continues parallel to the Main Southern Railway line train line for approximately 320 m to the Menangle Park Zone Substation. The landform in this area appears to have been cut and filled in areas where it levels out around Howes Creek. It has also been modified by the construction of bridge with introduced basalt bedrock on the northern side (Figure 14 and Figure 15). A portion of the area has also been infilled with concrete and a tunnel has been built under the railway line Figure 16. The proposed works in this area will include deep under boring.

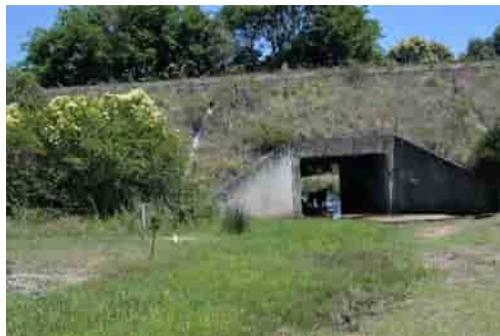
Figure 17: View north along the east boundary of the Menangle substation

The area bordering the east of the existing Menangle Zone Substation is undulating under foot and has been disturbed by the construction of the substation which would have included excavation and fill. There is also a modified drainage depression along this area Figure 17. The artefact reburial site, AHIMS 52-2-4396 (Figure 18) was inspected and confirmed to be outside of the area of proposed works.

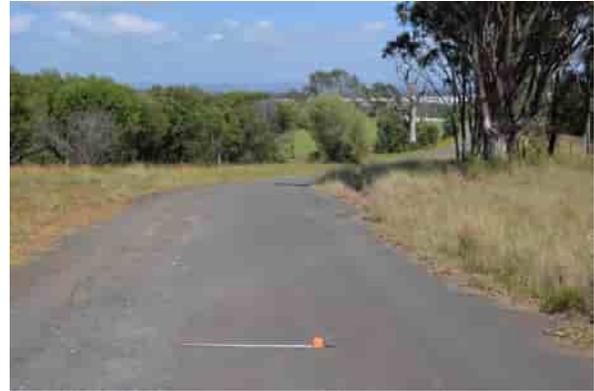
Figure 8: Eroding asphalt on Glenlee Road

The northern section of the study area includes an approximately 450m long section of Glenlee Road, which provides access to Glenlee Estate. Glenlee Road is an eroding, asphalt road with infrequent exposures on the road verge (Figure 8). The road sloped moderately to steeply from the east to west until it reached Glenlee, which was not accessible. On approach to Glenlee drive, the road became increasingly eroded and gravelly with numerous potholes (Figure 9). There was evidence of subsurface impacts due to services (Figure 10). No evidence of former road surfaces was visible.

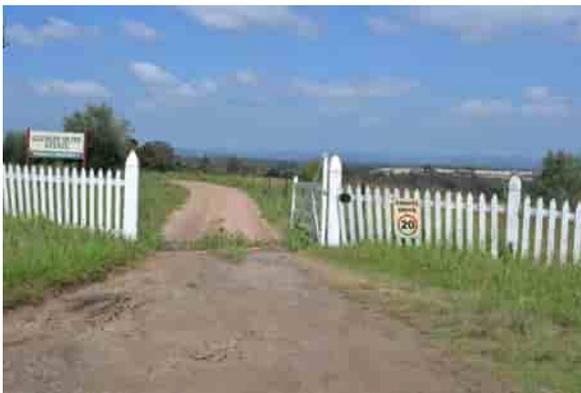
Figure 9: Gate of Glenlee property, noting poor condition of road

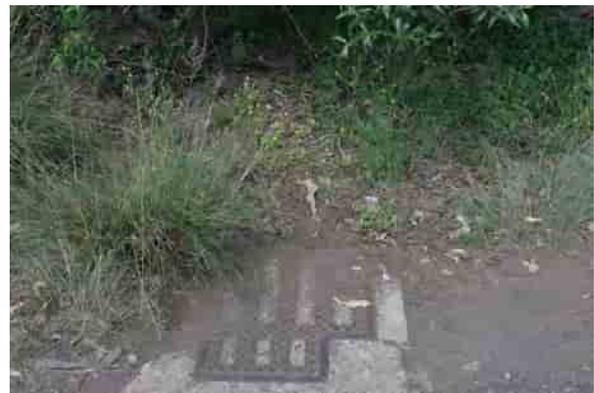
Figure 10: Evidence of subsurface impacts from services

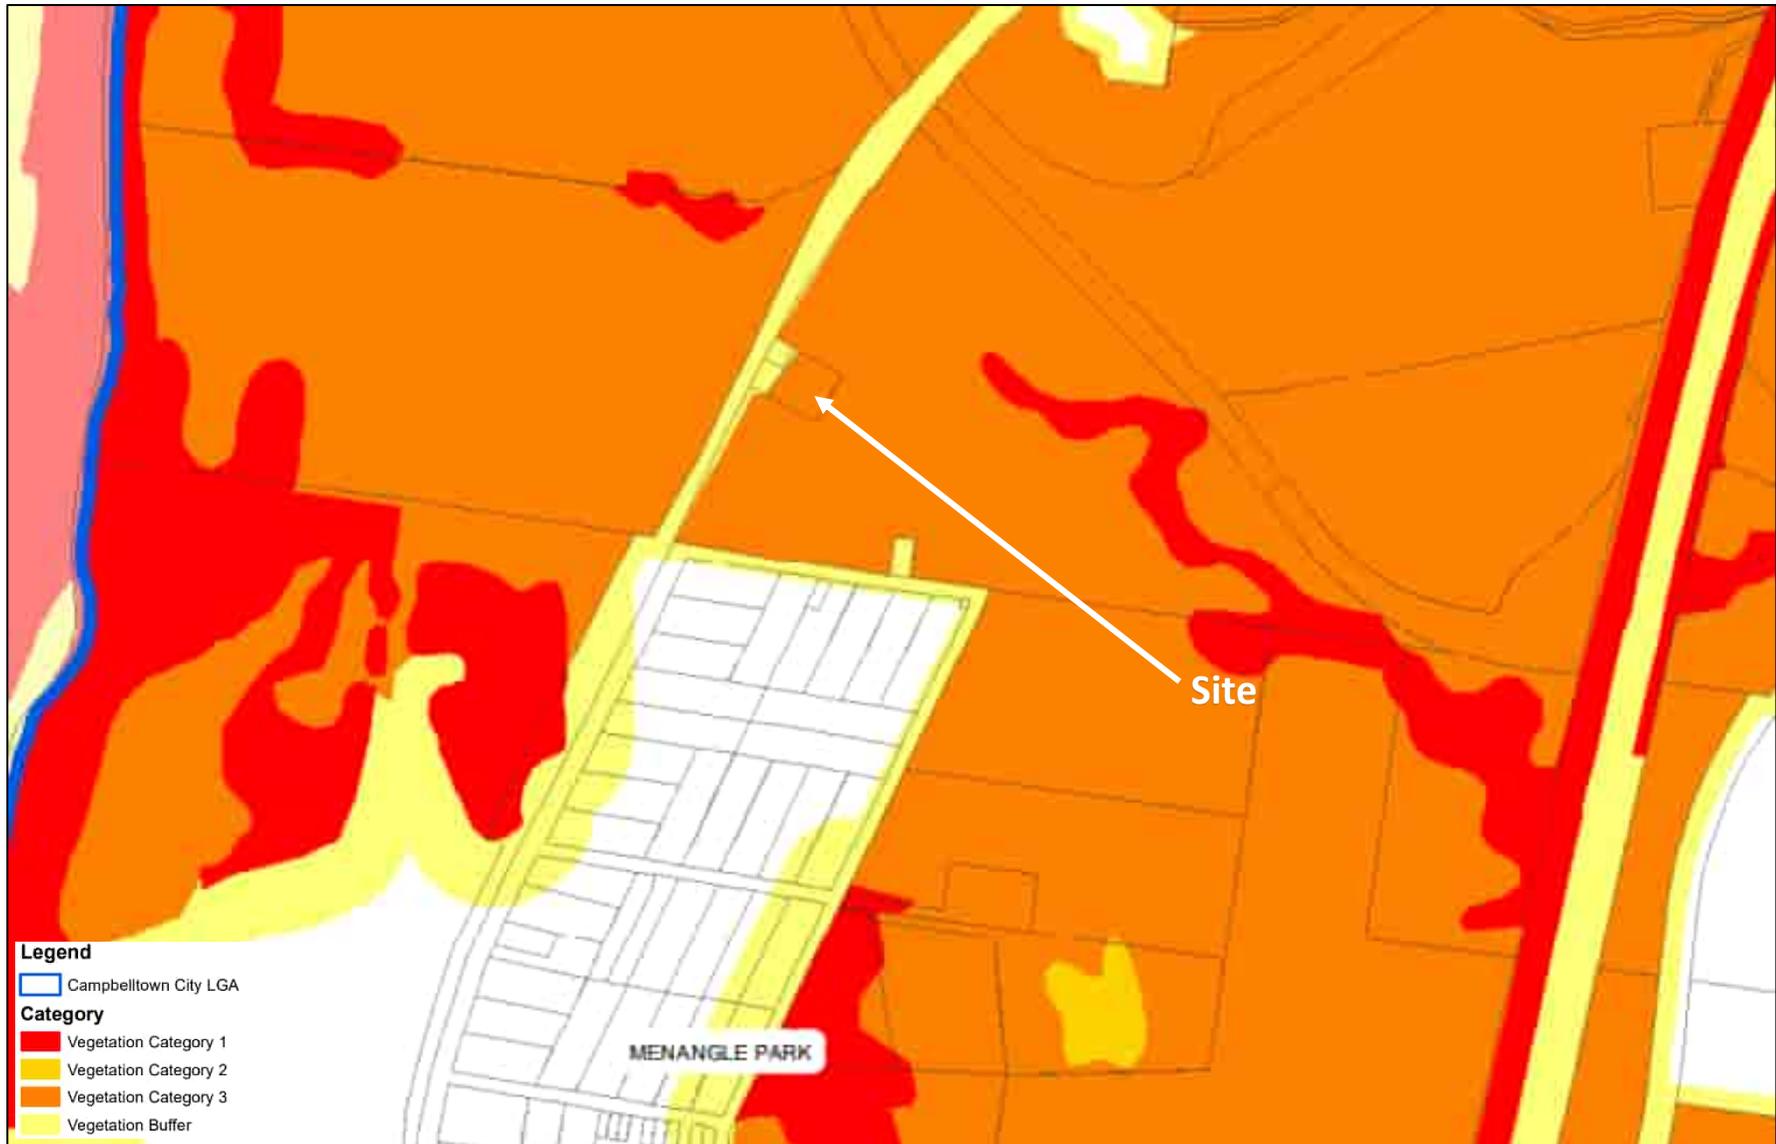
Figure 3 Bush fire Prone Land Map (Extract online Campbelltown Council, 2025)

The grassland surrounding the Site is designated as being bush fire prone on the BFPL map and it is able to carry a bush fire. As such, the unmanaged grassland areas have been treated within this bush fire Hazard Assessment as a hazard.

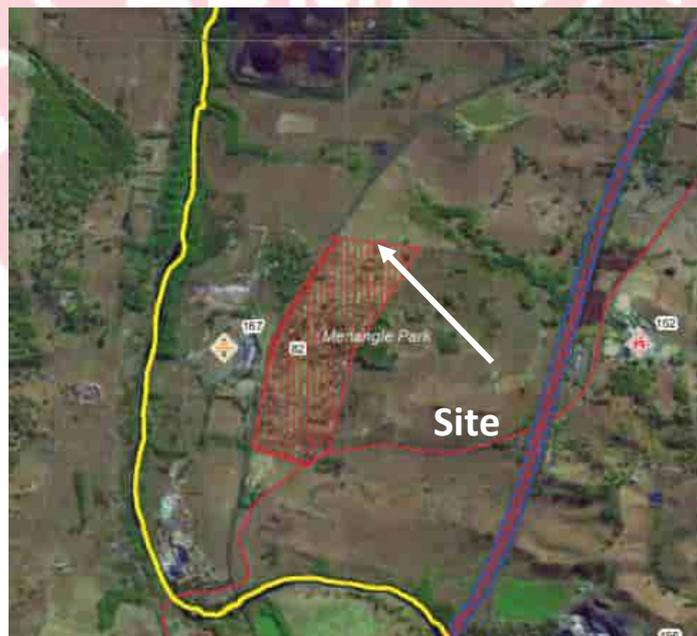
Zone characteristics: An area in the landscape where land management outcomes are also prioritised such as those related to social, cultural or environmental values, or those related to the management of agricultural and natural resource assets.

Treatment Scheduling: Managed for Natural and cultural outcomes

Figure 4 Extract from Bush fire Risk Management Plan for the site (source Macarthur Bush fire Risk Management Plan)

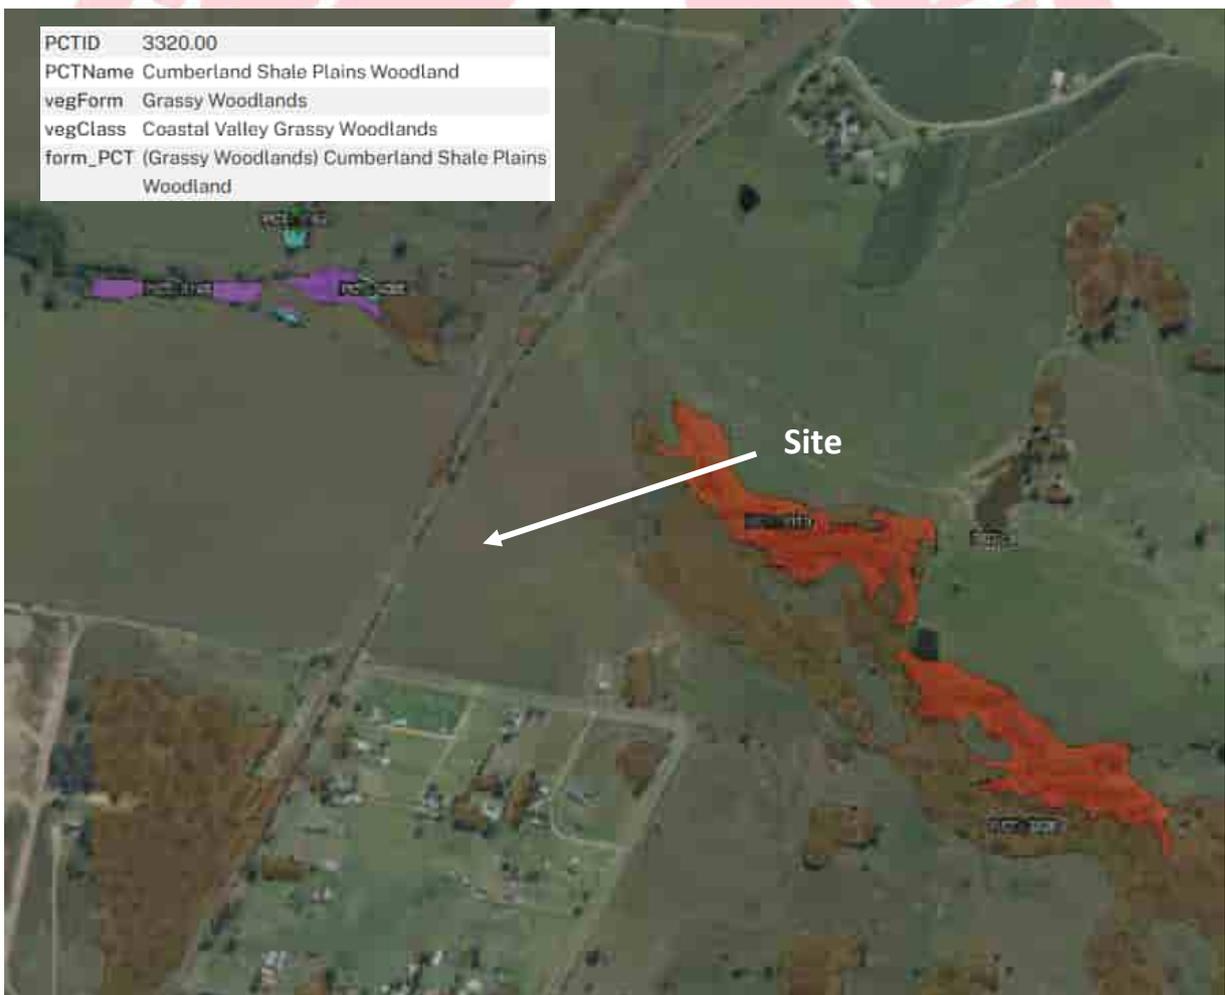
Predominant vegetation is classified by structure or formation using the system adopted by David Keith (2004) and by the general description using PBP 2019. Vegetation types give rise to radiant heat and fire behaviour characteristics. The predominant vegetation has been determined for the Site over a distance of at least 140 metres in all directions from the proposed Site boundary or key assets on the Site. Where a mix of vegetation types exist, the type providing the greater hazard to the Project Area is said to predominate. The land surrounding the dominated with unmanaged grasslands derived from Site is PCT 3320 - Cumberland Shale Plains Woodland (Keith Vegetation Class: Coastal Valley Grassy Woodlands) with small patches of PCT 3110 Greater Sydney Enriched Grey Myrtle Dry (Keith Vegetation Class: Dry Rainforests) within riparian areas in the surrounding creek line and water courses. Inside the facility would be managed to Asset Protection Zone Standards and would be managed land.

Figure 7 State Vegetation Type Map (SEED Portal, 2025)

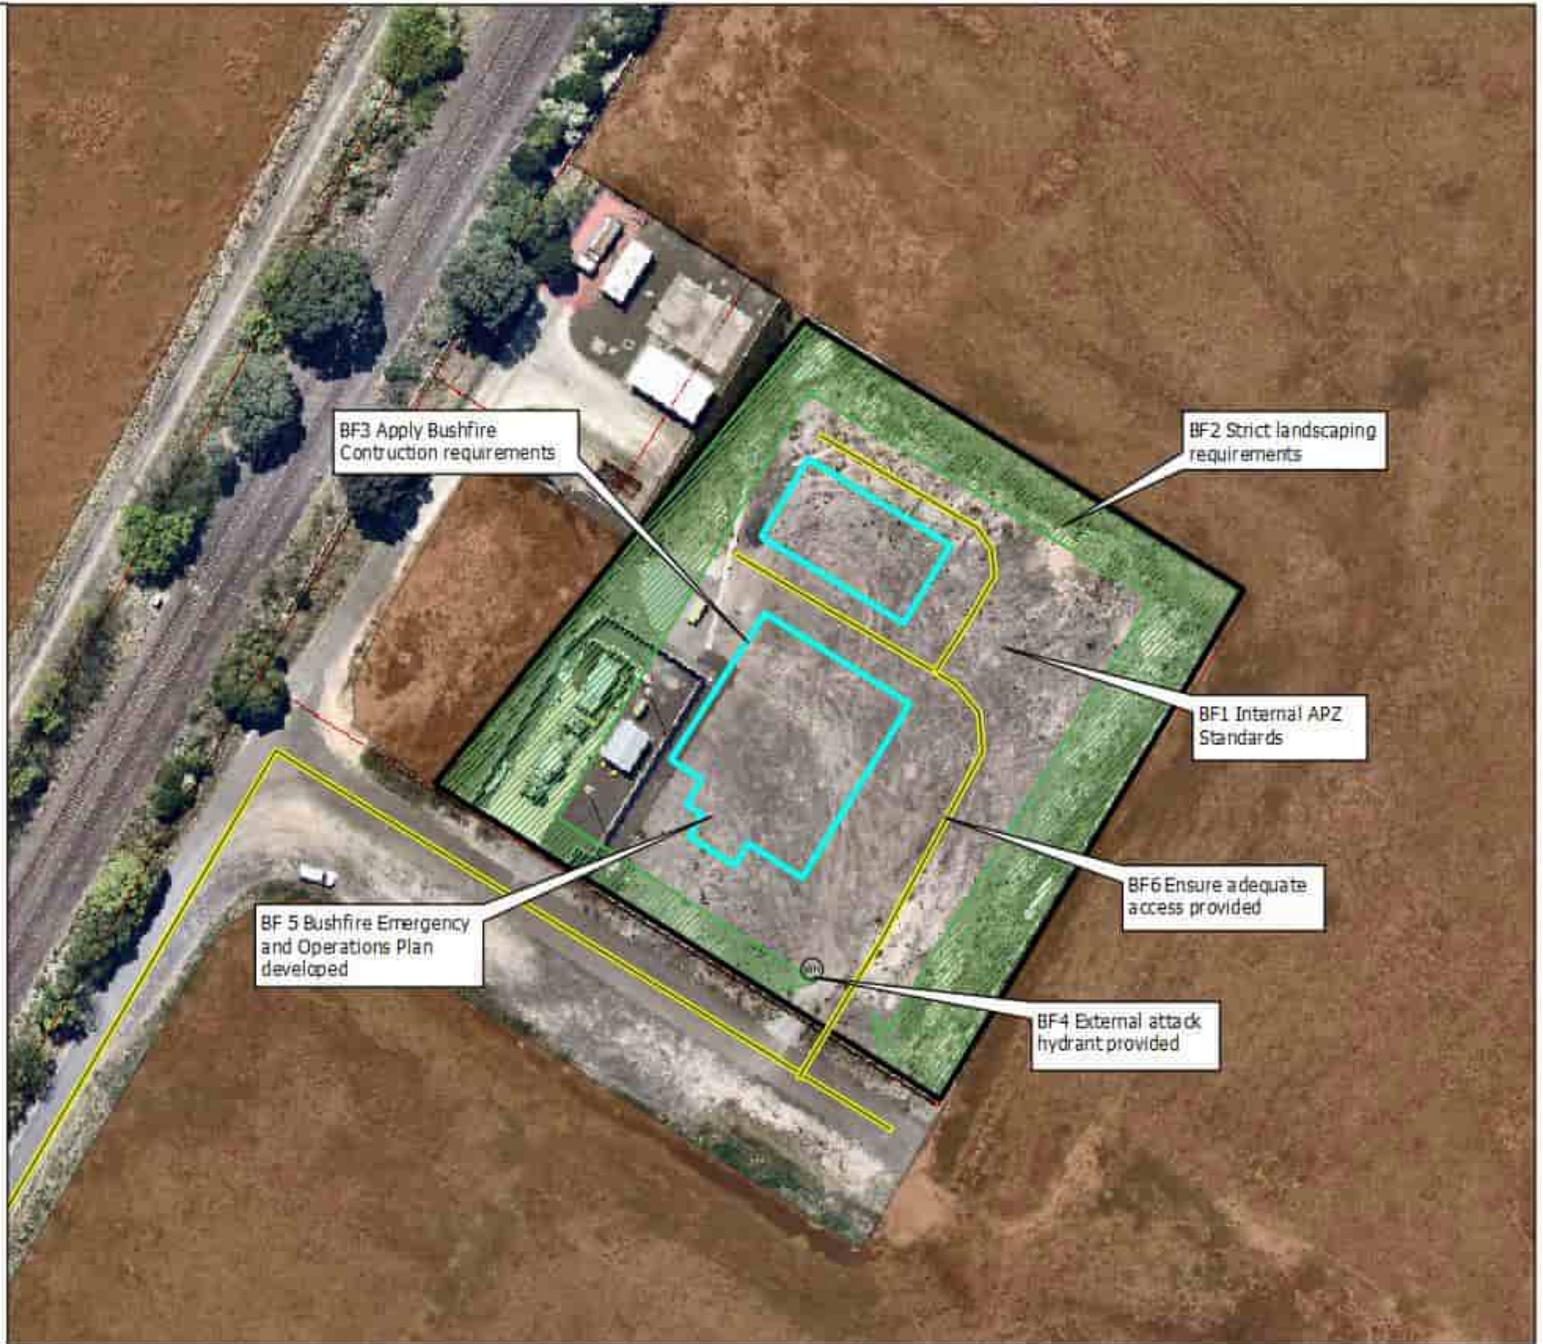
BF3 Apply Bushfire Construction requirements

BF2 Strict landscaping requirements

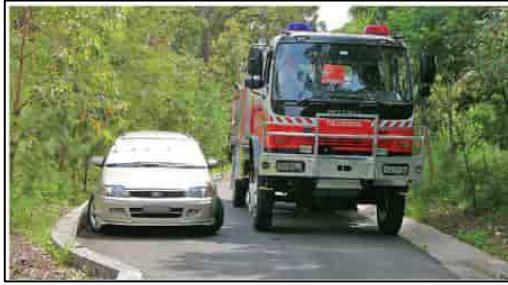
Passing Bays

The construction of passing bays, where required, shall be 20m in length, provide a minimum trafficable width at the passing point of 6m.

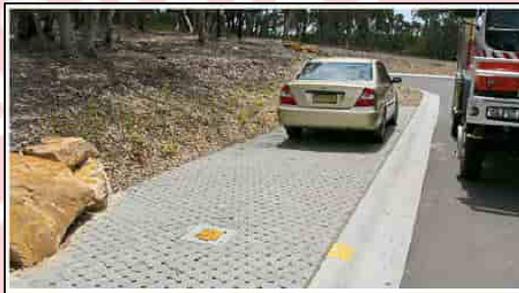
Parking

Parking can create a pinch point within the road reserve. The location of parking should be carefully considered to ensure fire appliance access is unimpeded. Hydrants should be located clear of any parking areas to ensure that access is always available.

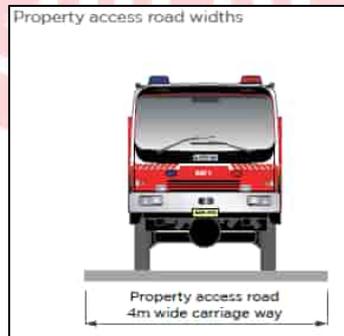
Road Types

Property access is required to be 4m wide all-weather road. Can be sealed or unsealed.
