# Safety Management System Performance Measurement Report

October 2025

# Executive Summary

The report provides information regarding the performance of Endeavour Energy's Electricity Network Safety Management System (ENSMS) which has been prepared in accordance with the Electricity Supply (Safety and Network Management) Regulation 2014 (ESSNM). It comprises two sections:

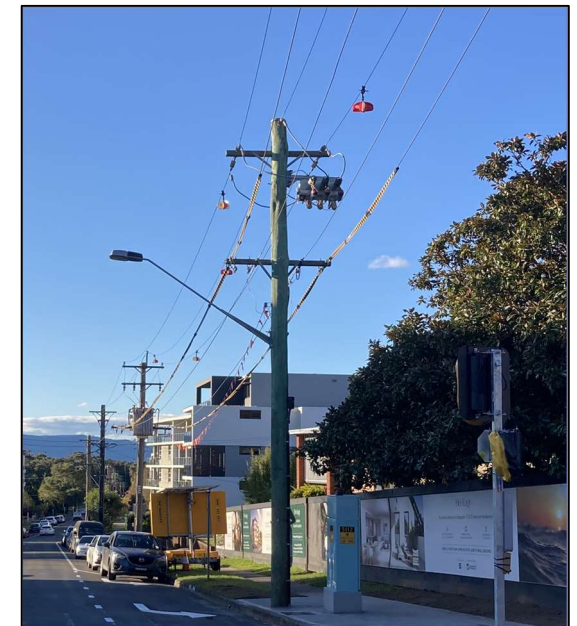
### Case study: Public Safety – Aerial markers and improved visual indication to reduce the risk of plant and equipment overhead powerline contact

Endeavour Energy is promoting and installing 'rota markers' to help reduce unintentional blindness on construction sites and enable better visual indication of the presence of powerlines. The use of these aerial markers is expanding across the transport, logistics and construction sectors with continued promotion and advocacy.

Energy Queensland were early adopters of rota markers on a large scale across their network and have reported considerable success with a 75% reduction in OH strikes within their agricultural footprints.

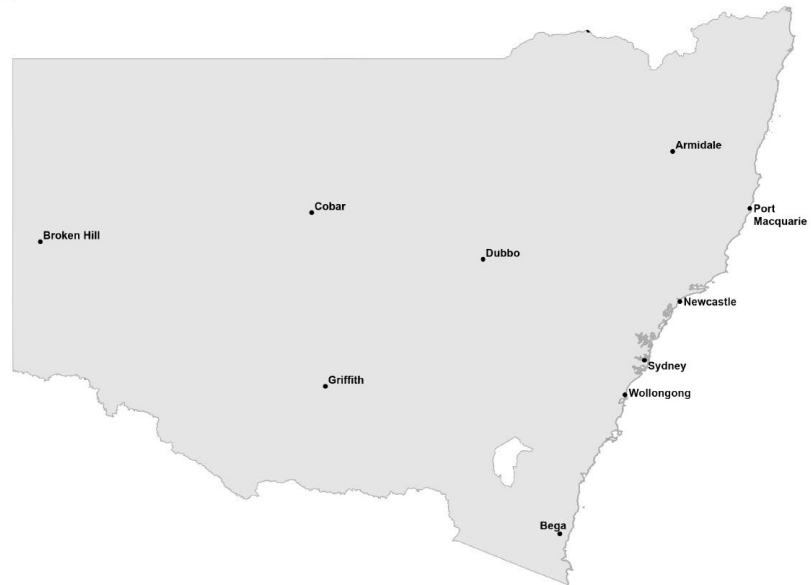
Figure B.3 – NSW AFAC Spring 2025 Season Bushfire Outlook

Consistent with the rainfall outlook, the Australasian Fire and Emergency Service Authorities Council's (AFAC) Seasonal Bushfire Outlook (Spring 2025) does not flag elevated early-season bushfire potential for NSW, and the NSW Rural Fire Service (RFS) 2025–26 Fire Season Statement anticipates a later onset to higher fire danger given a wet spring—while noting above-normal grass growth and recovering forest fuels may increase risk as the season progresses.

Operationally, this leads to reduced ignition risk within the network area in the first half of the fire season. Additionally, gaining access to sites to rectify some vegetation and network defects has been challenging due to water inundation in certain areas of the network.

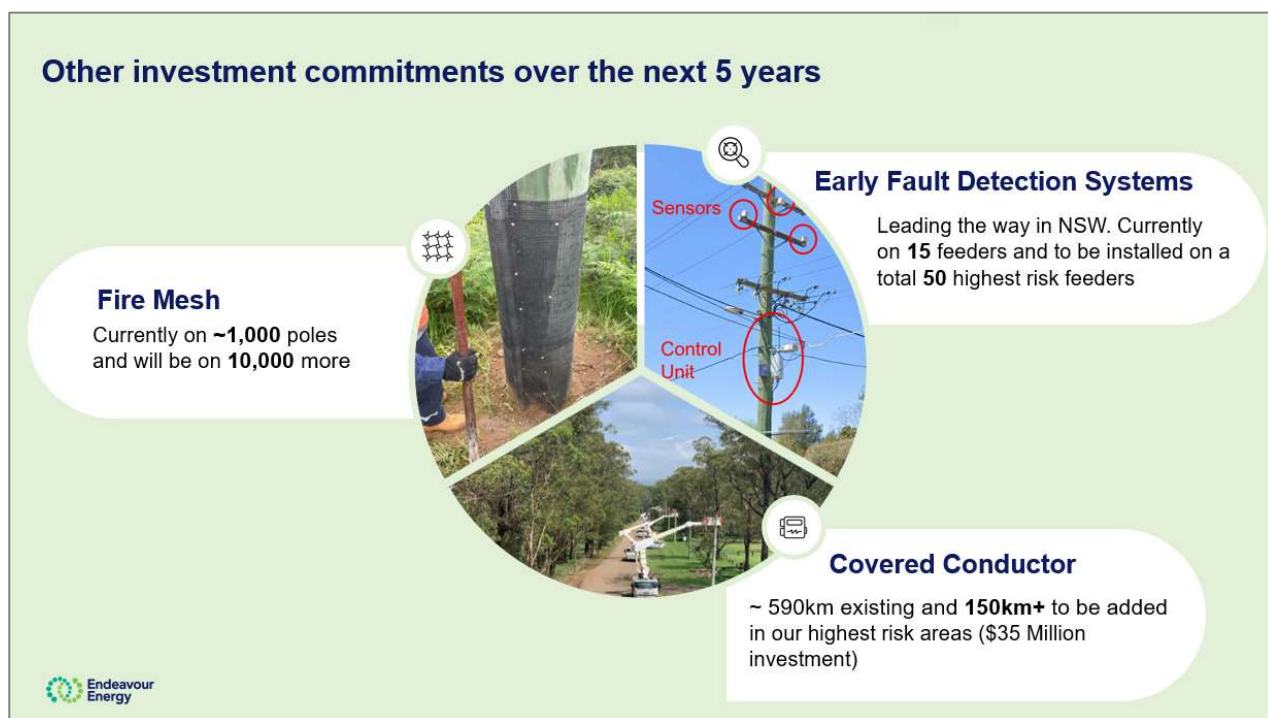
Figure B.5 – Bushfire Mitigation Investments in the coming years

To help minimise safety and bushfire risks Endeavour Energy delivers annual vegetation programs to keep vegetation clear of powerlines. Clearance requirements are based on the Industry Safety Steering Committee (ISSC) 3 - Guide for the Management of Vegetation in the Vicinity of Electricity Assets.

In heavily vegetated areas where clearing is problematic, alternatives such as line relocation, conversion to covered conductor or underground conversion may be considered where appropriate.
