ENSMS Performance Report

01 July 2022 to 30 June 2023

Executive summary

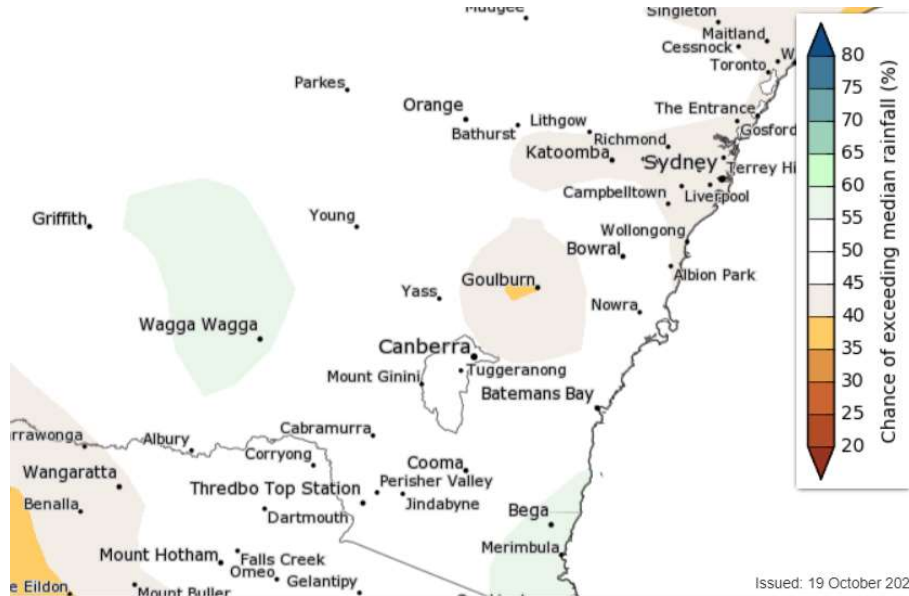
Figure 2 – Chance of above median rainfall – November 2023 to January 2024

The Bureau of Meteorology has declared an El Nino event in progress, coupled with a positive Indian Ocean Dipole. This normally results in above average temperatures and below average rainfall across the Endeavour Energy network area, resulting in deteriorating bushfire conditions for the bushfire danger period.
